Patient safety program and incident review of high-dose-rate brachytherapy at an academic center in Thailand

Division of Radiation Oncology, Department of Radiology, Faculty of Medicine, Siriraj Hospital, Thailand

Abstract

J Contemp Brachytherapy 2022; 14, 4: 390-397

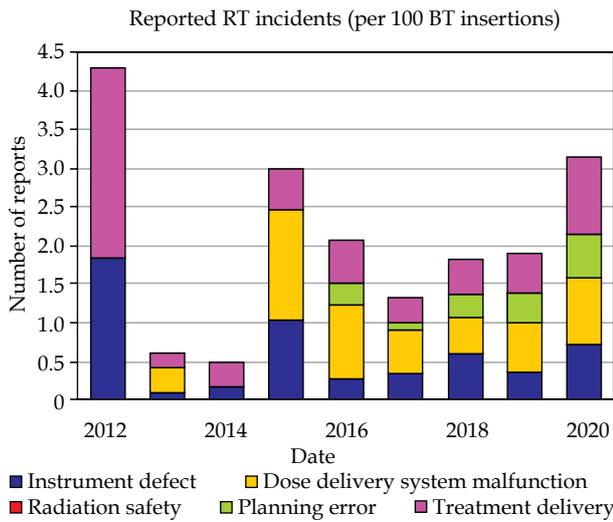
Fig. 2. Reported RT incidents over time by event type

All issues arising from BT application (99% gynecological cancers with about 2% of HDR prostate implantation) during more than 9 years of implementation were collected and categorized (Table 2). Reported RT incidents over time by event type are shown in Figure 2. The incidents were classified as 'near-miss', 'not harmful', and 'harmful' according to the International Classification for Patient Safety [26]. They are summarized in Table 3.
