Compressed valve in a calcified right ventricular outflow tract

Postep Kardiol Inter 2013; 9, 3 (33): 294–295

Key words: transcatheter valve implantation, congenital heart disease.

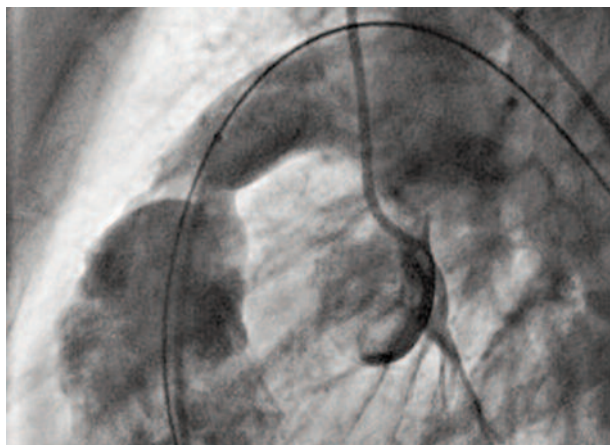
Fig. 1. Pulmonary angiogram – left lateral view; significant pulmonary incompetence and RVOT stenosis

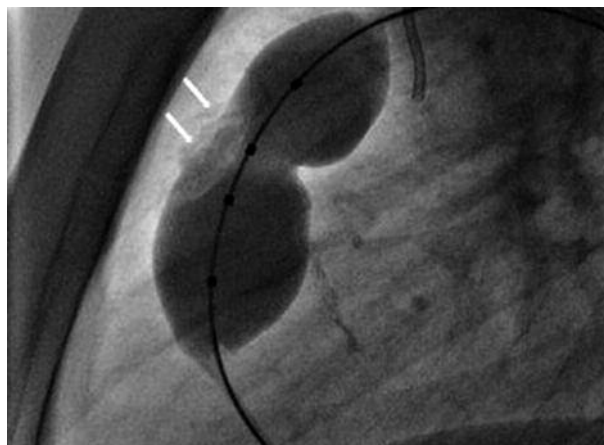
Fig. 2. Measurement of the size of the RVOT with the balloon – left lateral view; balloon waist marks the landing zone for the bare metal stent pre-stenting and the valve; the opacity in the part of the balloon located opposite to the posterior waist is caused by severe calcifications in the anterior wall of the RVOT (arrows)

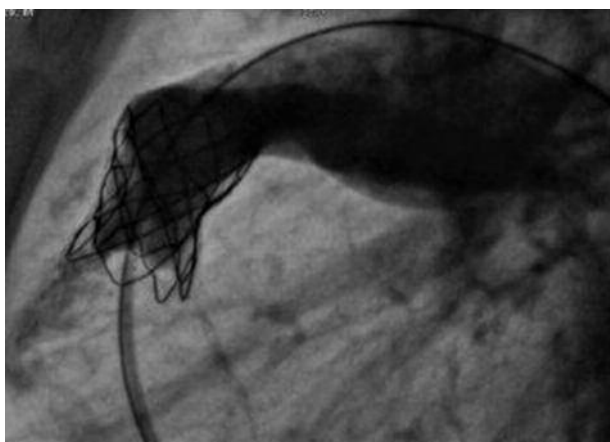
Fig. 3. Pulmonary angiogram, left lateral projection, immediate result after prestenting and Melody valve implantation: proper valve expansion, competent valve

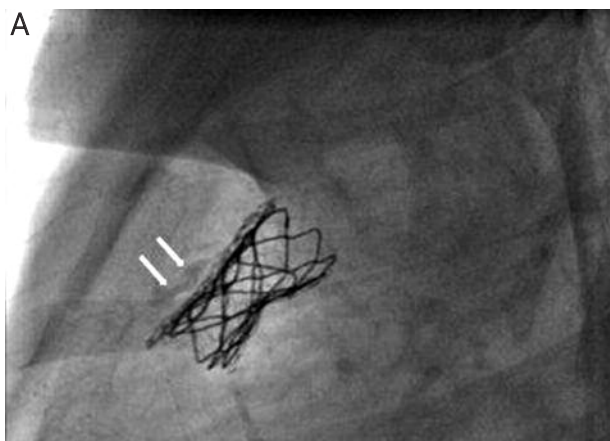
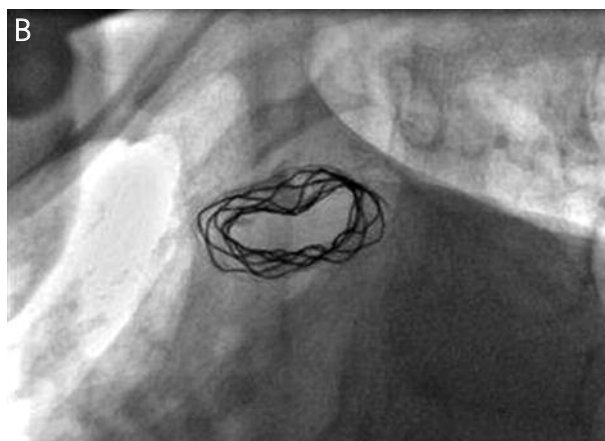
PA gradient was 108–121 (mean 60) mm Hg. The chest X ray showed a compressed valve-stent in the right ventricle outflow tract (RVOT) (Figures 4 A and B). The patient was scheduled for surgery. The pulmonary artery with the squeezed valve was removed (Figures 5) and the pulmonary homograft was successfully implanted. Extensive discentric RVOT calcifications may be connected with a risk of early valve compression. A staged procedure, with at least double-stent pre-stenting and delayed valve implantation, should be considered in this situation.

Fig. 4. The day after implantation. **A** – Left lateral projection, **B** – LAO + caudal projection: squeezed valve-stent by severe calcifications of the anterior wall of the RVOT (arrows)

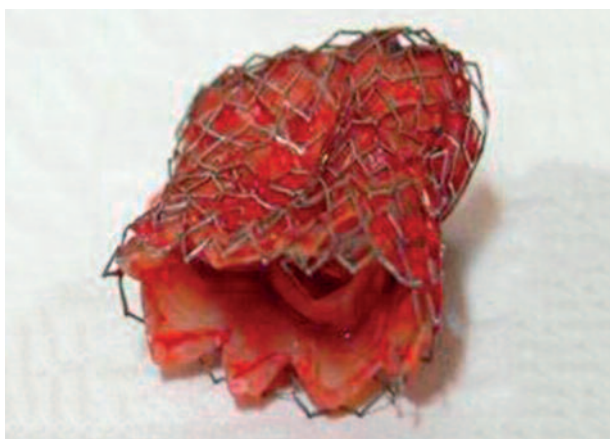
Fig. 5. Explanted compressed Melody valve
