Contralateral pneumothorax after cardiac pacemaker implantation

Postępowanie Kardiologiczne 2015; 11, 4 (42): 347–348

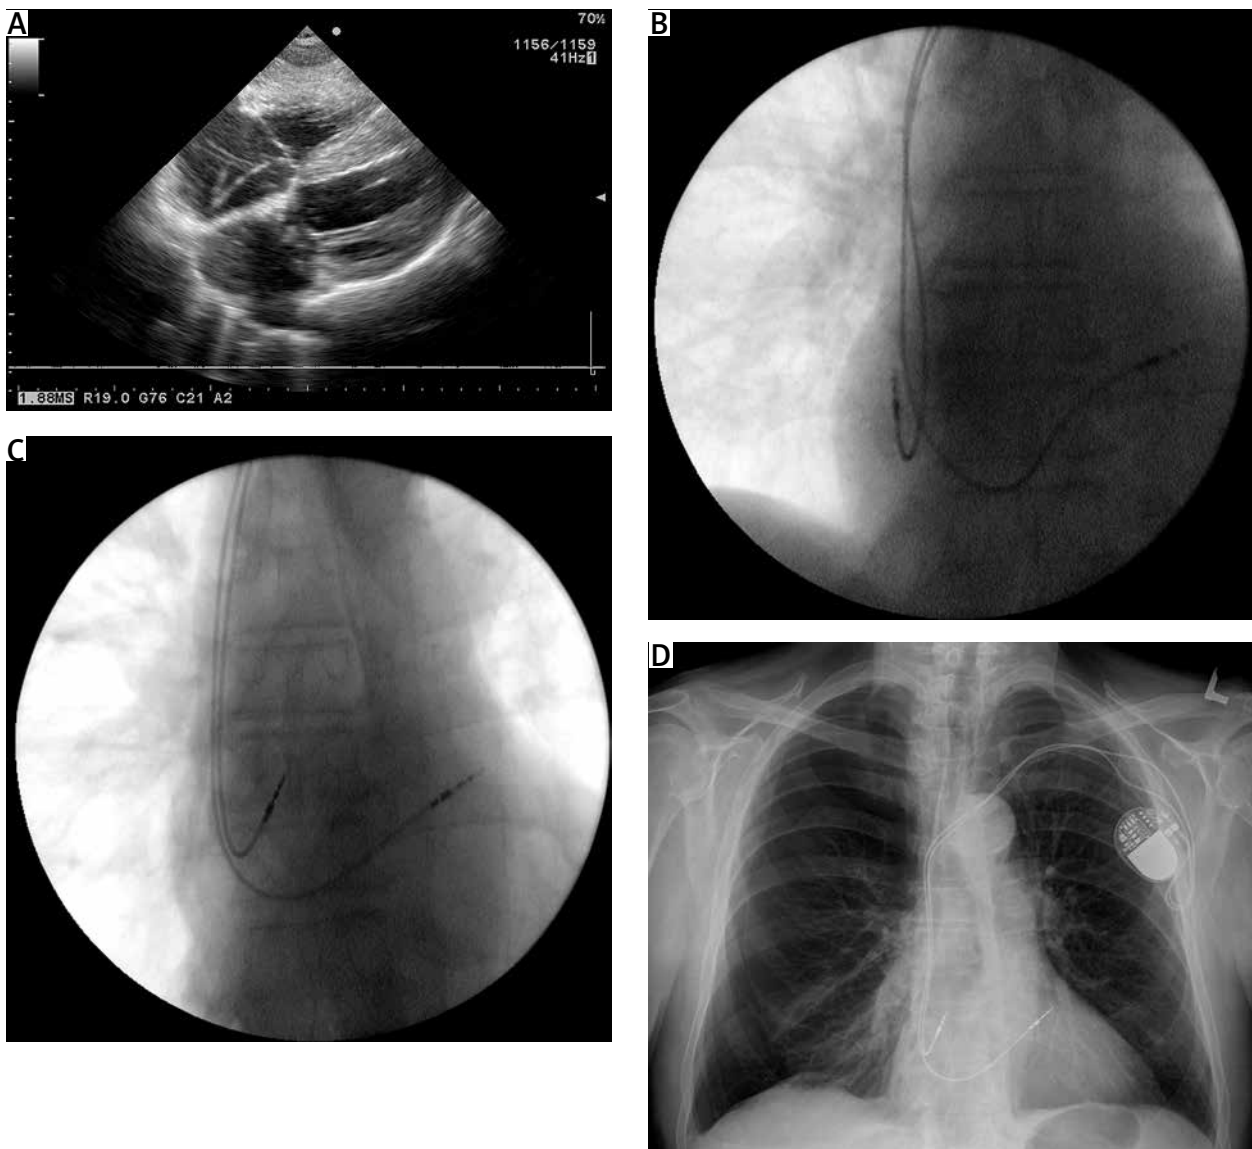
Figure 1. A – Echocardiographic study showing parts of the atrial and ventricular lead and no signs of pericardial fluid excess. B – Fluoroscopy after first implantation. C – Fluoroscopy after spontaneous dislocation of atrial lead. D – Right-sided pneumothorax after pacemaker implantation

perforation (Figure 1 A). The device was reprogrammed to bipolar stimulation, leading to a decrease in reported complaints.

On the next day a lack of atrial lead capture by threshold > 7.5 V/ 1.5 ms was recorded. Fluoroscopy revealed dislocation of the atrial lead, which was extracted subsequently. New lead was implanted through subclavian vein puncture into the right atrial appendage, obtaining good parameters (Figures 1 B,C). Several hours after reoperation the patient reported resting dyspnoea. Chest radiograph revealed large right-sided pneumothorax (Figure 1 D), which was cured by suction drainage.
