## Retention of temporary epicardial pacing wires: when migration causes dehiscence of a sternal wound

Kardiocirurgia i Torakochirurgia Polska 2023; 20 (2): 123-125

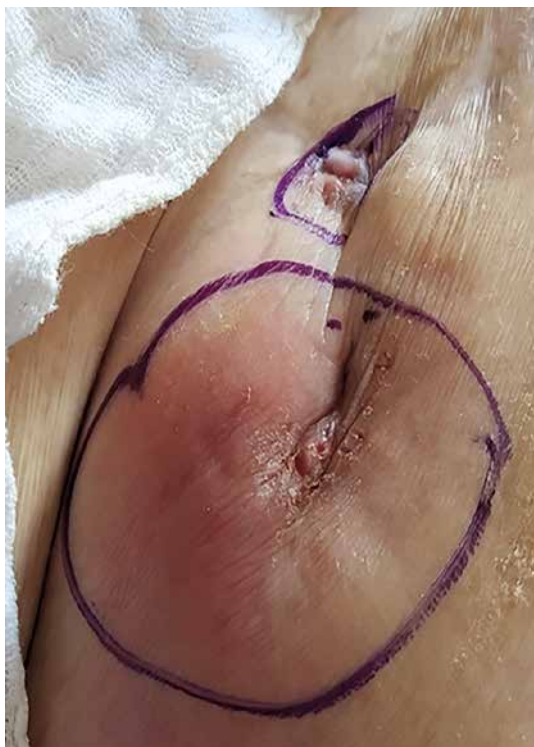
**Figure 1.** Patient abdomen: swelling of the upper and lower portion of the wound

a surgical revision of the mediastinum. Two right atrial and two right ventricular epicardial pacing wires were inserted at the moment of the intervention and were not removed during the revision of the mediastinum; on the 6<sup>th</sup> postoperative day (POD), at the time of removal, only the ones placed on the right ventricle were removed without resistance, while the ones on the right atrium were cut flush with the skin. On the 8<sup>th</sup> POD, the patient presented strong chest pain, erythema and drainage from the distal third of the sternotomy wound associated with sternal instability; on the 10<sup>th</sup> POD she became feverish and blood cultures tested positive for *Proteus mirabilis* and *Staphylococcus epidermidis*. Despite antibiotic targeted therapy there was progressive enlargement of the dehiscence and vacuum assisted closure (VAC) therapy was started. Several swabs of the wound were performed, and when they tested negative for bacterial growth, the patient underwent reconstruction of the dehiscent wound through partial mobilization of pectoralis muscles. The remaining in-hospital stay and follow-up were uneventful and the wound perfectly healed. Four years later, she came back due to the appearance of a painful swelling at the distal third of the sternotomy wound, approximately 30 mm wide; thus, empirical antibiotic therapy was started as well as serial medications of the swelling. A week after the antibiotic therapy was started, the swelling in her upper abdomen increased in volume and started to drain purulent fluid; another swab was performed and tested positive for *Proteus mirabilis*; therefore targeted antibiotic therapy with ciprofloxacin (500 mg/day) was started (Figure 1).

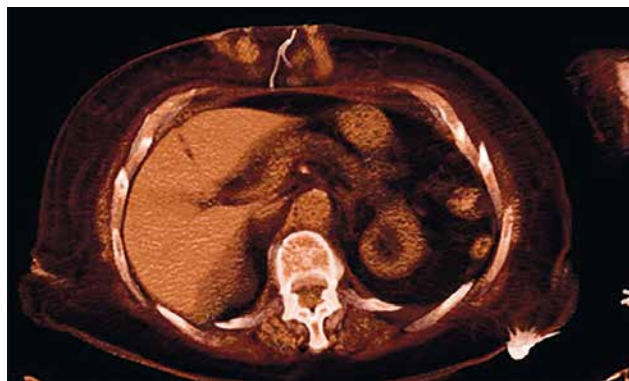
**Figure 2.** Computed tomography (CT) scan images of the retained wires in the subcutaneous tissues of the patient (axial plane)

of the wound; therefore a computed tomography (CT) scan was performed and it revealed the presence of a foreign body in the patient's mediastinum which appeared to be the retained TEPWs (Figures 2–4).

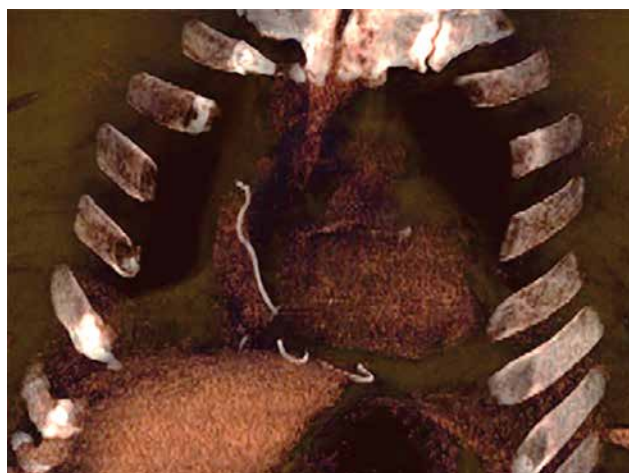
**Figure 4.** Position of the retained wires, CT scan (coronal plane)

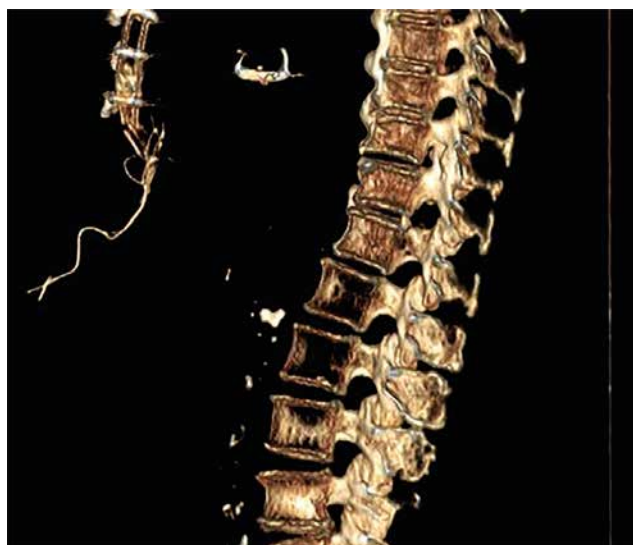
**Figure 3.** Retained wires, 3D reconstruction of the patient's CT scan (sagittal plane)

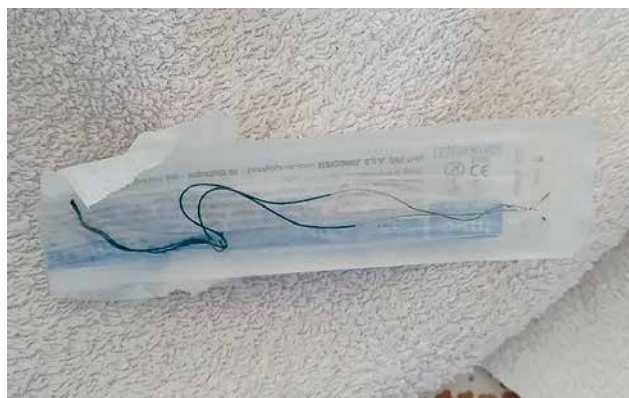
**Figure 5.** Extruded TEPWs

It was then decided to schedule her admission in order to remove the retained wires safely, but eventually, 7 days before the hospitalization the epicardial wires exited spontaneously through her upper abdomen by doing gentle compression of the area by herself. A few days after the extrusion, the wound healed completely with only a few medications needed (Figure 5).
